# CTIF NEWS

## Extra follow-up

### Can we be better prepared?

### Garbage truck explosion in Indianapolis 27 January 2015

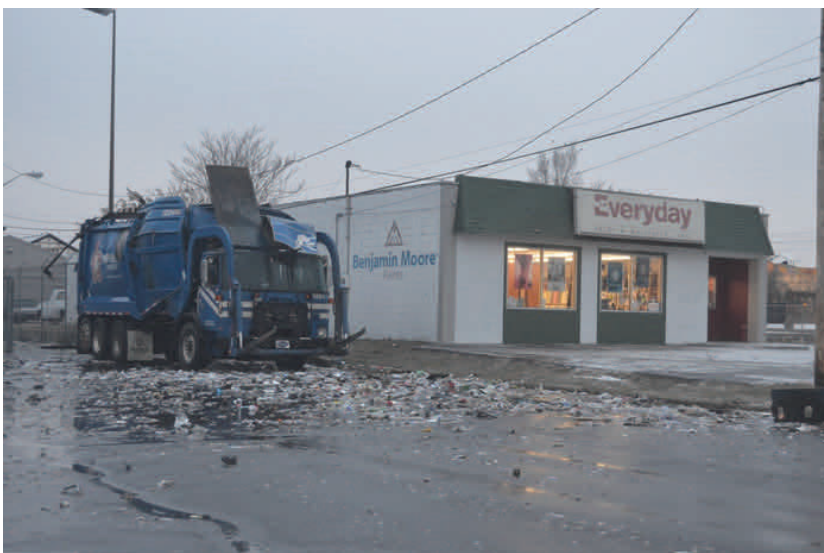
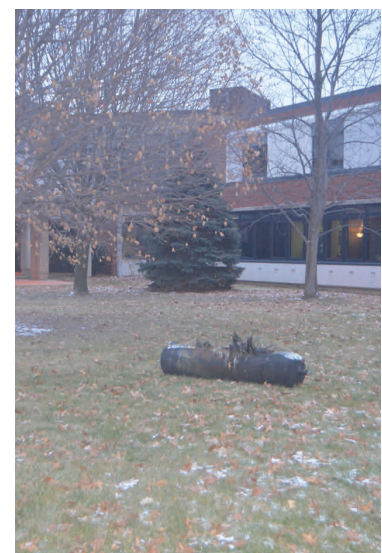
The first arriving unit, Engine Co. 6, received information the fire involved compressed gas cylinders and requested additional resources at 05:45 hours.

An elevated water stream was deployed to cool the tanks and contain the fire.

The tank explosion occurred at 06:06 hours.

The resulting debris field extended approximately three-quarter miles (1.2 kilometers) from the explosion site, with one CNG cylinder landing in front of a nearby school.

The vehicle involved sustained significant damage, with only minor damage to nearby structures.

**Findings, (extract):** From a tactical perspective, if a vehicle is known to be equipped with CNG cylinders and is well involved with fire, firefighters should maintain a safe perimeter and not approach the vehicle, unless there is a significant life hazard, i.e. let the vehicle burn. A minimum evacuation radius of 300 feet (90 meters) should be maintained in such incident types. As experienced in this event, a tank landed approximately

4,000 feet (1,200 meters) away. Do not approach from either the front or the side of the vehicle. If necessary, approach a CNG vehicle fire from a 45° angle.

If the PRD(s) have activated, do not apply water spray, but rather allow the fire to burn.

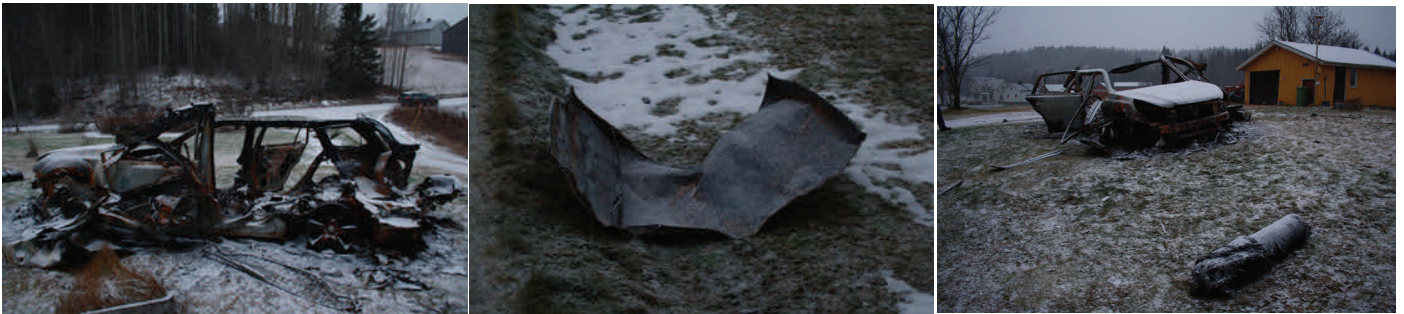
### Gas propelled car exploded in Kramfors, Sweden 16/11 2016

The explosion blew away the roof of the car and it landed approx. 1 meter from one firefighter

The car had started to burn and then it exploded, it was a gas-propelled car. We took a defensive position and allowed it to burn out before finishing the intervention. It was parked in a quite remote position and there was no risk for fire spread.

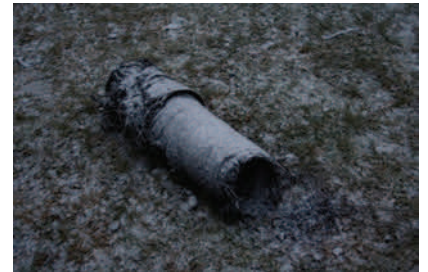
We were lucky and nobody was injured, Mikael Lundberg, Officer on Duty at the High Coast Rescue Service.

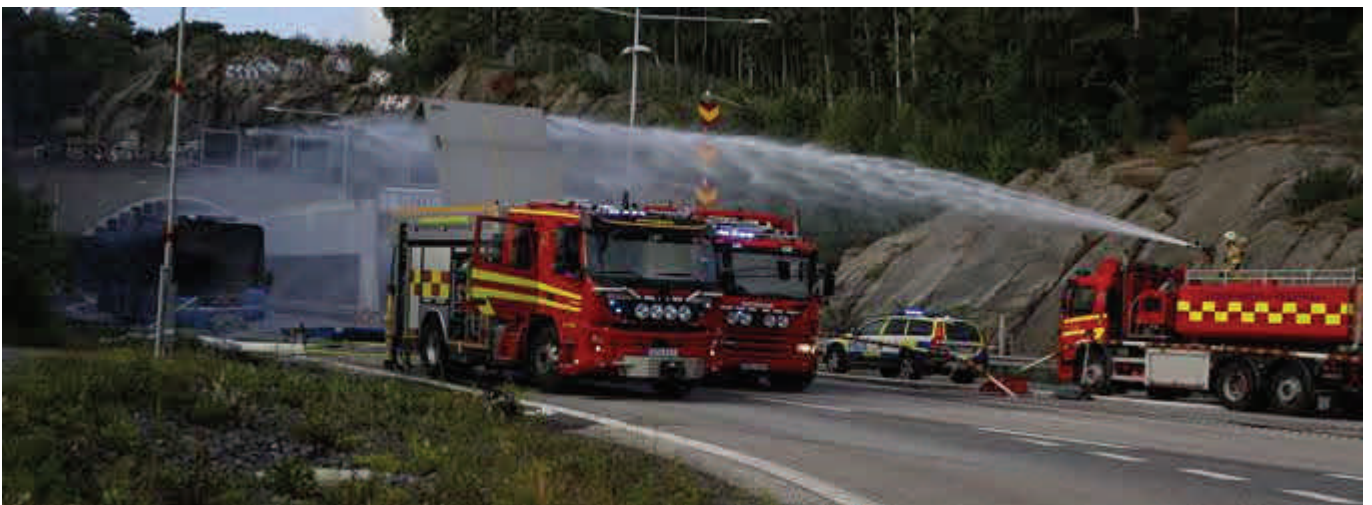
### Gas-propelled bus exploded in Gothenburg, Sweden 2016-07-12

A gas propelled bus started burning after passing through a tunnel in Gothenburg. It had 15 passengers on board that managed to get off the bus. During the intervention of the Rescue Service, the bus exploded. Two firefighters were slightly injured.

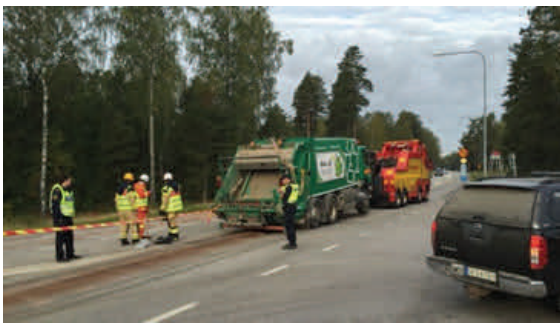
### Garbage truck exploded in Sweden 2016-09-22

At ten o'clock in the evening a garbage truck was on its way to the garage after having been refueled with biogas. One gas container exploded. The persons in the cab were shocked, but nobody was injured.

*The wreck was towed away the following morning. Photo: Robin Persson/SVT*

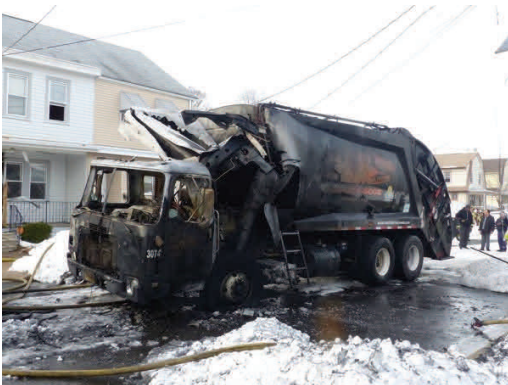
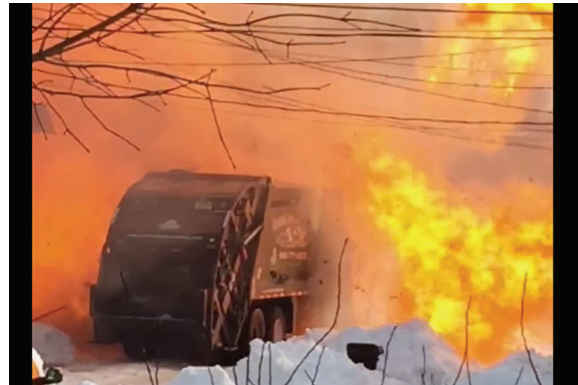
### Garbage truck exploded in New Jersey, USA 2016-01-26

HAMILTON -- A garbage truck exploded after catching fire on a street in Hamilton and blasted a hole in the front of a nearby house, though no injuries were immediately reported.

One of the truck's four natural gas tanks exploded in the fire and rocketed into the front of Doris Pattley's home on Fitzrandolph Street, just off Lalor Street, officials said. Hamilton firefighters Leonard Pope and Steve Lykes had just pulled Pattley from the rear of her home when the truck exploded, officials said. The explosion shot debris into a second home across from Pattley's, tearing a hole in the roof.
