ATR fire - Hangar F June 2012

Airport Prague Fire Brigade

Hangar F - general

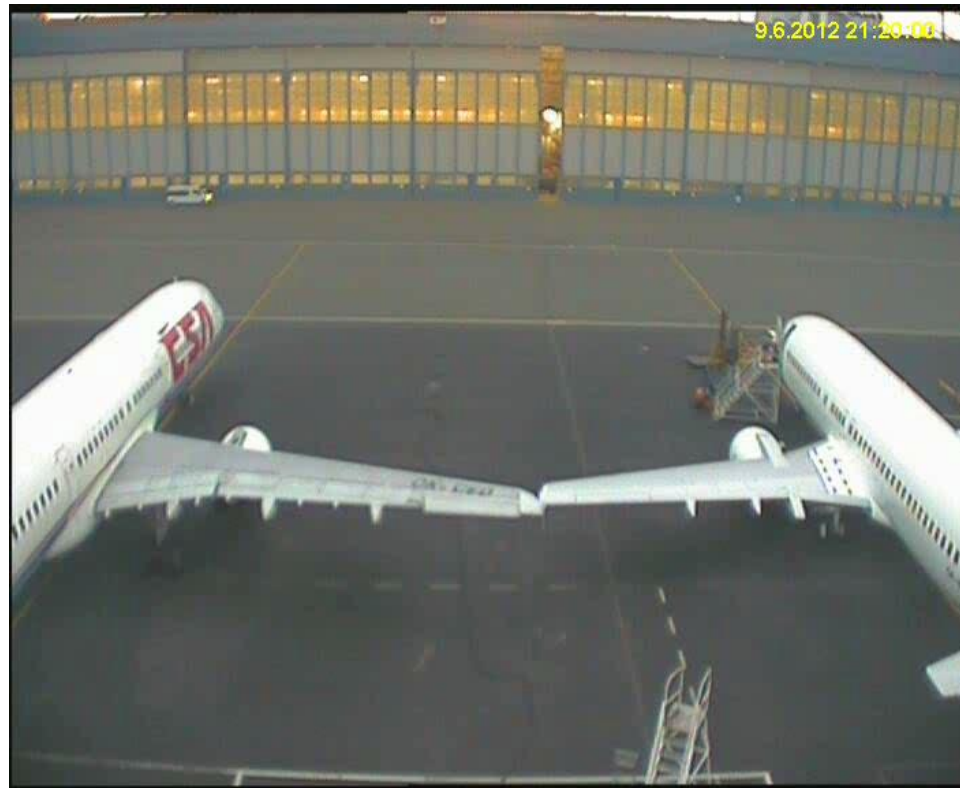
CCTV cameras offside hangar

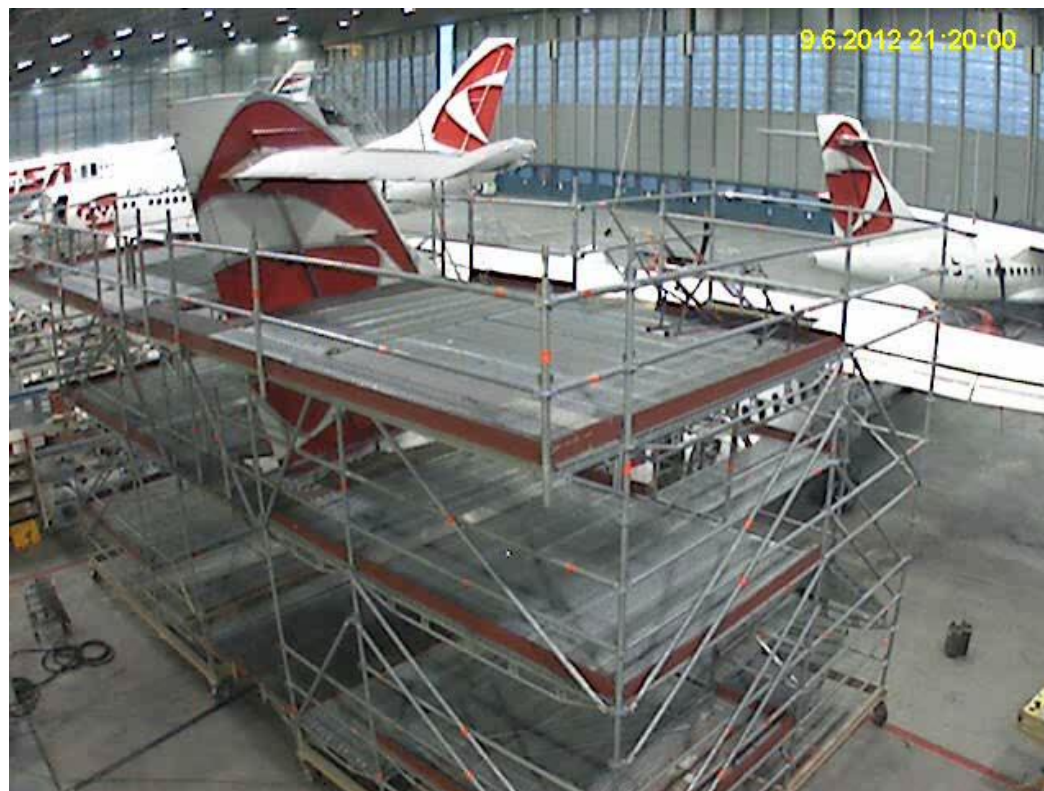
CCTV camera inside hangar hall
